UNITED STATES ENVIRONMENTAL PROTECTION AGENCY

Re: Town of Brookhaven
SPDES Permit No. NYR20A411

This is in reference to the United States Environmental Protection Agency's (USEPA) Region 2, MS4 Compliance Evaluation Inspection (CEI) at the subject facility on April 12 thru April 28, 2011. This inspection report will be referenced as an addendum to EPA's MS4 Audit conducted on June 7-9, 2011. The Town of Brookhaven is in non-compliance with Part VII.A6 of the New York State Department of Environmental Conservation SPDES General Permit For Stormwater Discharges from MS4 under Pollution prevention/Good Housekeeping for Municipal Operations-SWMP Development/Implementation.

MS4 Inspection Report/Town of Brookhaven (NYR20A411) – April 12-14, and 25-28, 2011

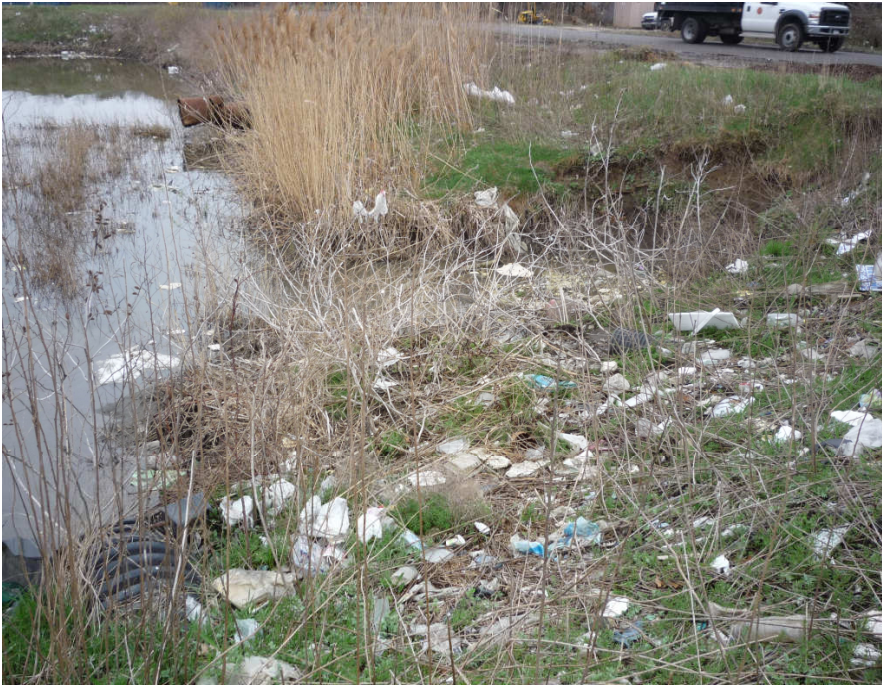
037 Brookhaven Transfer Station

EPA inspected the Brookhaven transfer station on 4/13/11 at 2:30pm. The facility is operated by a contractor for Town, and receives 500-1000 tons/day, approx. 200,000 tons/year. The solid wastes are compacted, loaded, and trucked out of state. The leachate is pumped to tanks and trucked to a separate disposal facility onsite. The transfer station's recharge basin for stormwater runoff contained excessive floatables, sheens, and excessive turbidity. It is recommended that screening for floatable and solids be employed.

037	Infiltration basin fill with debris, oil and grease and high turbidity
038	Infiltration basin fill with debris, oil and grease and high turbidity
039	Infiltration basin fill with debris, oil and grease and high turbidity
040	Salvage and abandoned oil tank
041	Equipment and materials storage and salvage

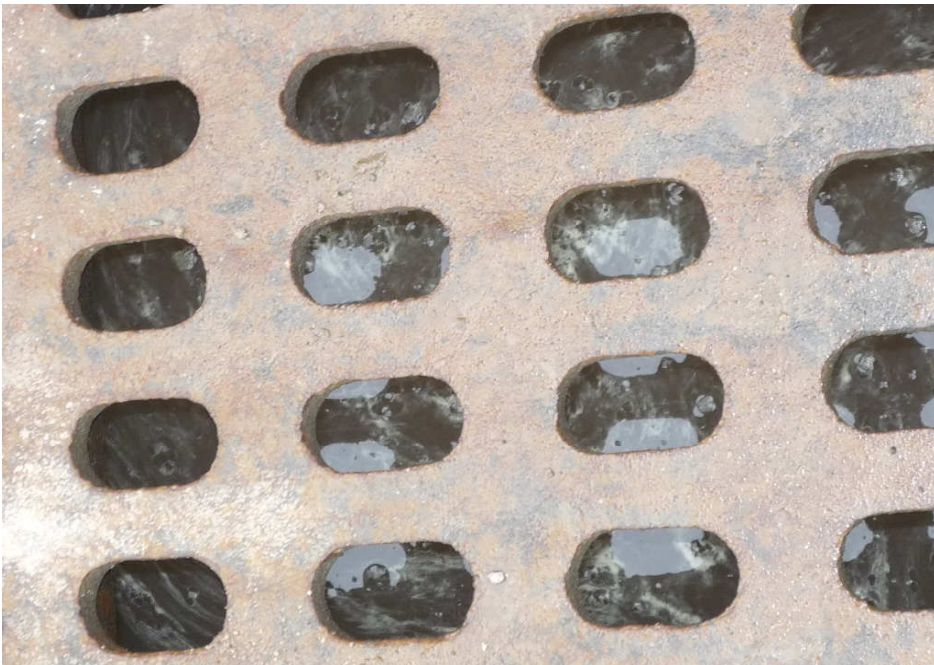
042 Mastic Beach Rd, Mastic Beach

Town of Brookhaven, NY (Unedited photos taken by Jerry Ciotola, Environmental Engineer, USEPA Region 2, Water Compliance Branch, April 12-14, 25-28, 2011)	
Photograph No.	Photograph Description
042	Sediment and grease in drains
043	Unbermed materials stockpiles
044	Unprotected stockpiles/erosion offsite
045	Unprotected stockpile/cold patch
046	Off site sediment tracking
047	Unprotected stockpiles/erosion offsite
048	Unprotected stockpiles/erosion offsite
049	Unprotected stockpile/cold patch
050	Abandoned unmarked drums stored in yard
051	Random storage of paints and solvents/some leaking
052	Open ditches of sediment, oil & grease, solids, and sludge
053	Open ditches of sediment, oil & grease, solids, and sludge
054	Open ditches of sediment, oil & grease, solids, and sludge
055	Unprotected stock piles/ salt eroding from shed
056	Unprotected stock piles/garbage and debris
057	Unprotected stockpile/cold patch (asphalt)

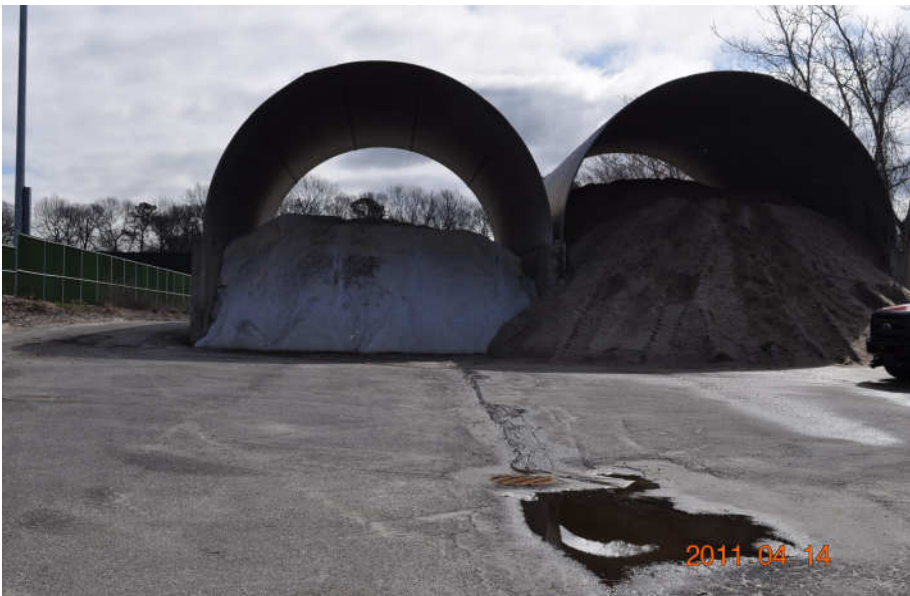
076 Horseblock Rd South Setauket

076	Unprotected stock piles/ salt eroding from shed
